## Appendix B. Summaries of OWEB-funded Tide Gate Related Projects

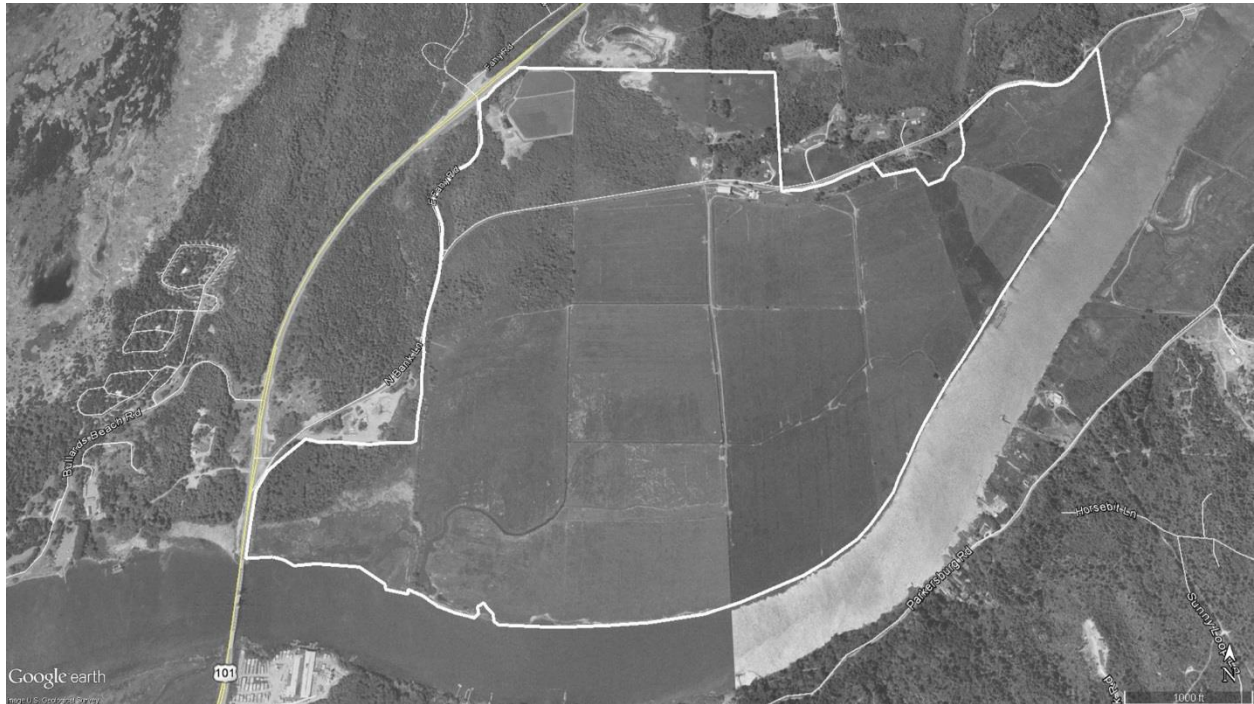
Ni-les'tun Tidal Marsh Restoration – Before (5/26/1994):

<b>Restoration Metrics:</b> 418 estuarine acres improved by channel modification, estuarine connection restored to 418 acres by dike/ berm removal/ modification	
<b>Monitoring Focus:</b> No monitoring under this restoration grant. Monitoring funded separately.	<b>Study Design:</b> N/A
<b>Parameters:</b> N/A	<b>Species Monitored:</b> N/A
<p><b>Project Findings:</b> Effectiveness monitoring indicated that the vegetative cover was moving toward native-dominated tidal marsh communities. Additionally, marsh use by native fish and aquatic invertebrates, and migratory shorebirds and waterfowl increased. Hydrology and channel morphology have also become more similar to reference conditions. Full tidal exchange has been restored. Tidal marsh function indicators are approaching or within the range of conditions at reference sites.</p>	
<p><b>Lessons Learned:</b> The potential to create mosquito breeding areas should be considered during the design phase, and will depend on the species present. 80,681 linear feet of tidal channel were excavated to alleviate water retention caused by restoration activity. A high priority should be placed on effective distribution of channels to provide adequate drainage for all areas of the site. Develop cost contingencies to support unexpected issues.</p>

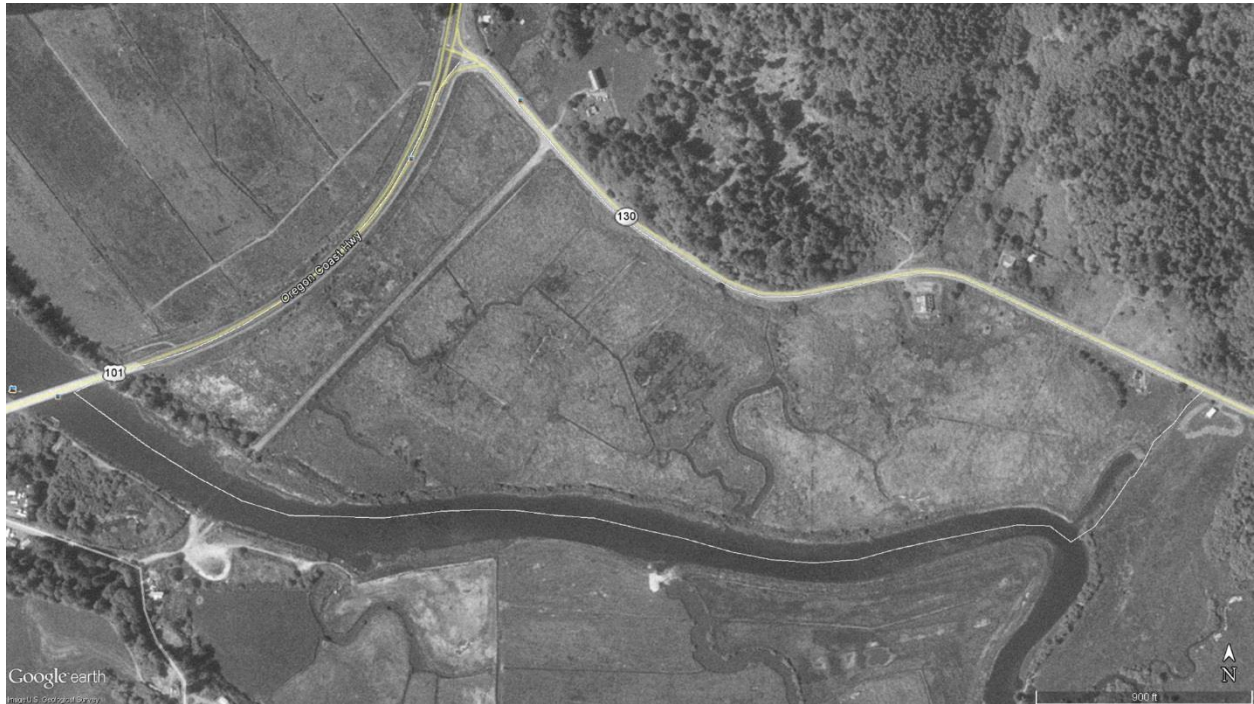
Little Nestucca River Restoration – Before (5/6/1994).

<p><b>Restoration Metrics:</b> 0.84 instream miles, 3 fish passage noncrossings, 1.4 fish passage non-crossing miles, 82 estuarine acres, 2 tidegates removed and 1 other diversion modified, 3462 feet in 3 main channels modified/ created, 9 log weirs installed(not below culverts), 20 anchored habitat structures placed, 0.2 miles grass seeding and mulching, 10 stations(1000 ft) road effectively closed to public use, 2 stations (200 ft) road obliterated, decommissioned, or vacated, estuarine connection restored to 82 acres and .64 miles by dike/ berm modification/ removal</p>	
<p><b>Monitoring Focus:</b> Biological</p>	<p><b>Study Design:</b> Vegetation was monitored using standard transects with quadrats. Plant communities were mapped over whole site. Evaluated change in plant community composition since 2001 baseline. Fish distribution was determined with seine sampling across a tidal cycle in Jun, Aug, and Oct. Tidal migration patterns were examined with underwater videography during the spring peak usage period. Macroinvertebrate distribution and abundance were described.</p>

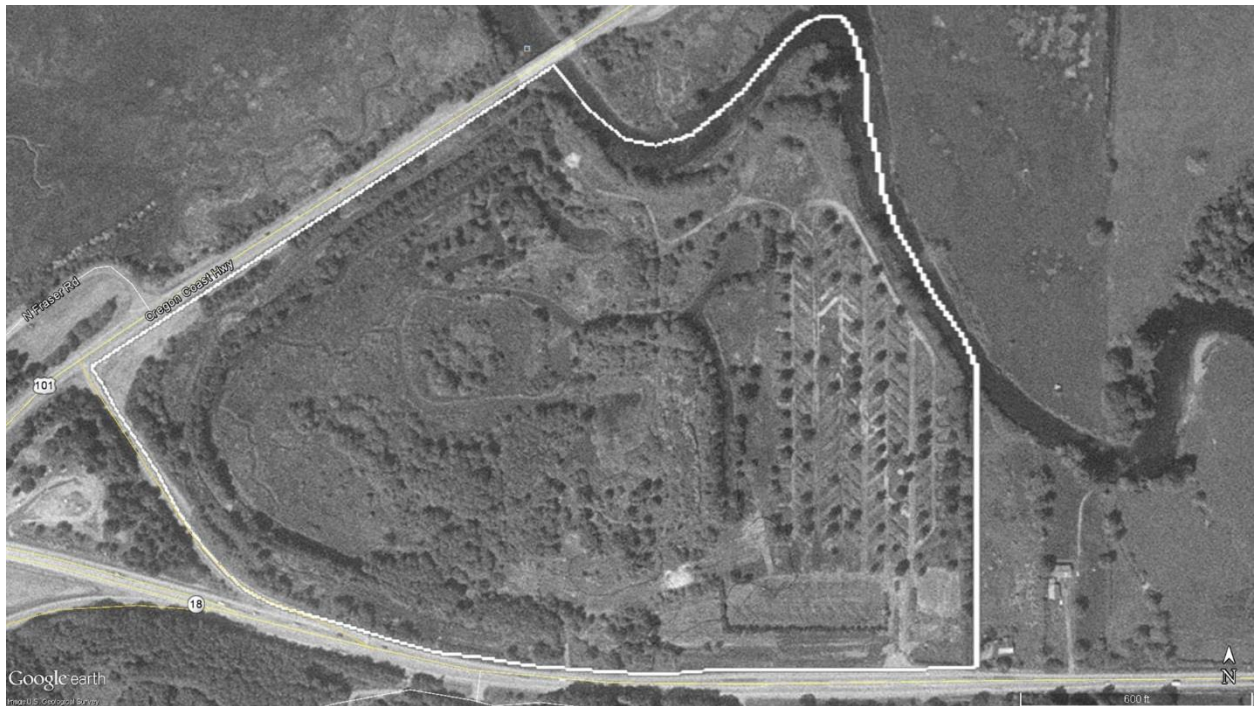
Pixieland Phase 1 Restoration – Before (5/5/1994)

<b>Restoration Metrics:</b> 1 instream miles, 40 estuarine miles, 5280 feet in 1 main channel modified/ created, esuarine connection restored to 40 acres by dike/ berm removal/ modification	
<b>Monitoring Focus:</b> N/A	<b>Study Design:</b> At the time of the report restoration was ongoing. No monitoring was described.
<b>Parameters:</b> N/A	<b>Species Monitored:</b> steelhead, chum, Chinook, coho, sculpin, cutthroat,
<b>Project Findings:</b> N/A	
<b>Lessons Learned:</b> Cost-effectiveness of different grading equipment was examined. An excavator and dump trucks were more efficient than a scraper. Coordination between disciplines is very important. Grading equipment and fish evacuation schedules had to be timed precisely. Grading work was divided among contractors, which made oversight and scheduling difficult.	
<b>Data Gaps:</b>	
<b>Project Reports:</b> Final Report and Accounting, 2/2012	
<b>Associated Publications &amp; Reports:</b> Brown, L. and L. Brophy. 2015. 2015 Monitoring Report: Pixieland Tidal Wetland Restoration. Prepared for Salmon-Drift Creek Watershed Council, Neotsu, Oregon. Corvallis, Oregon: Green Point Consulting, Estuary Technical Group, Institute for Applied Ecology. Ellingson, K.S. and B.J. Ellis-Sugai. 2014. Restoring the Salmon River Estuary: Journey and Lessons Learned Along the Way 2006-2014. Report to Siuslaw National Forest, Corvallis: OR.
