Appendix C. Summaries of Primarily Non-OWEB funded tide gate projects in Oregon, and tide gate projects in Washington and California, 2006 – 2016.

Appendix C. Summaries of Non-OWEB tide gate projects, 2006 – 2016.

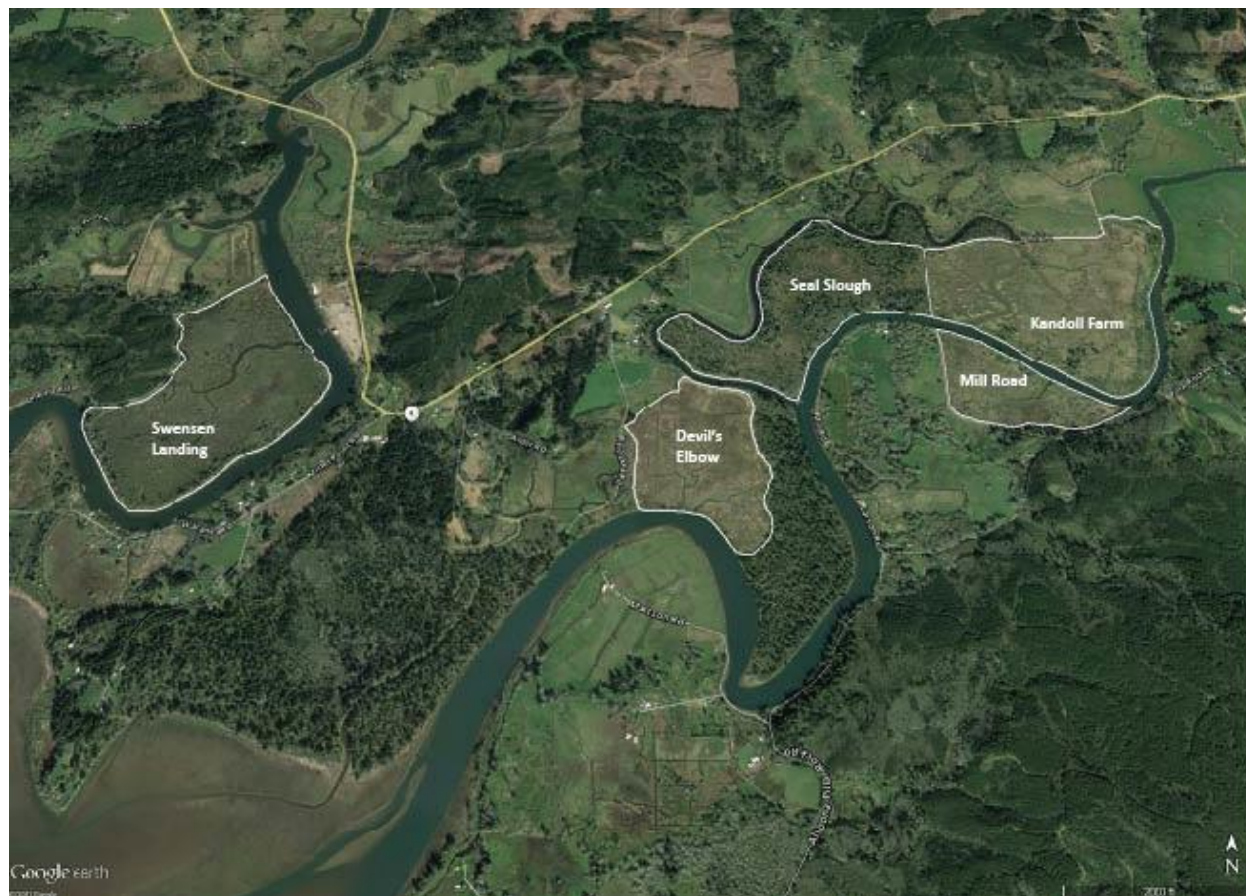
Aerial Images: Restoration projects in the Grays River and Deep River confluence, WA (3/20/2016).

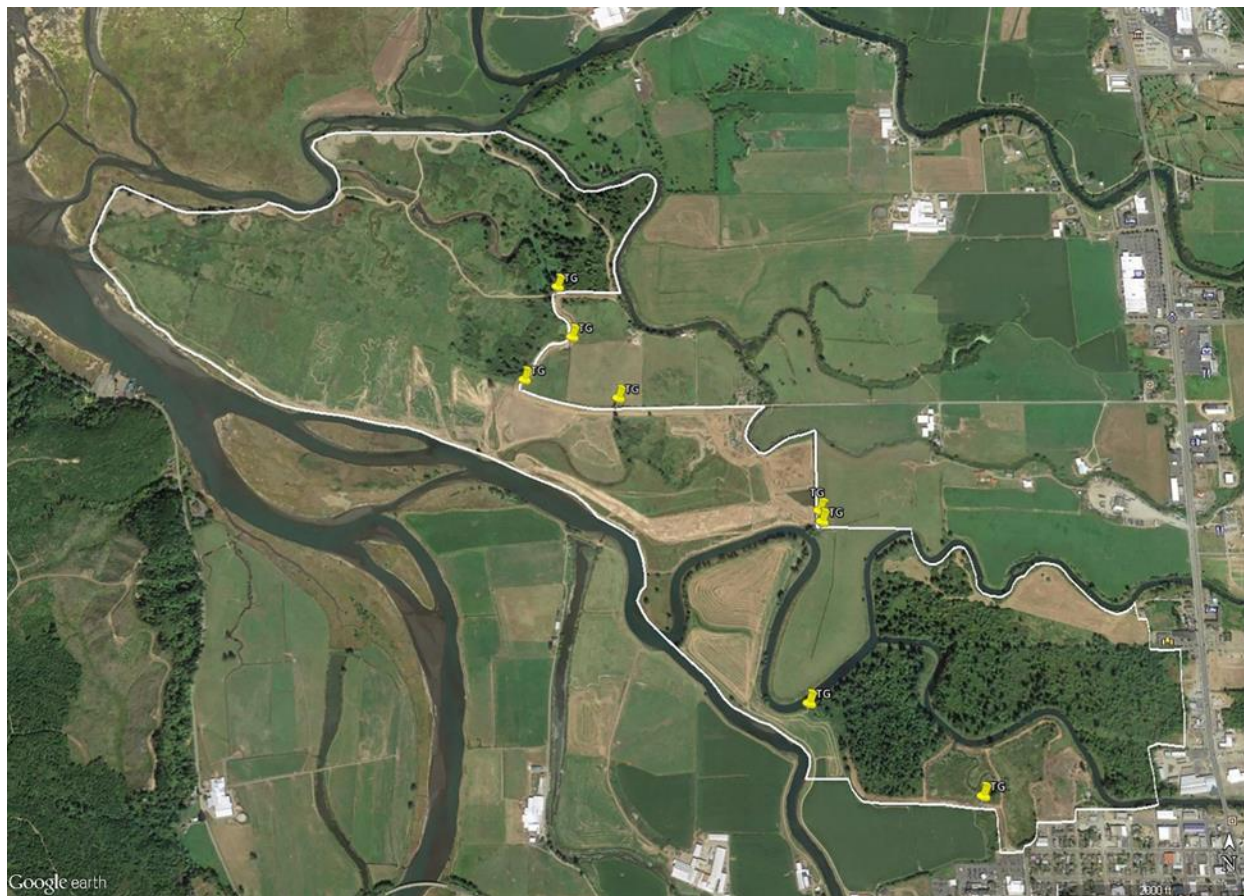
Southern Flow Corridor project area at beginning of construction, showing locations of new tide gates (8/23/2016):

Restoration Metrics: Levee/road Removal-9 miles; levee, dredge spoil, & fill removal-195,000 yd³; levee modification-2.8 miles; new levee-1.5 miles; tide gates removed -15; new floodgate/drainage tide gates-1/8; structures removed-1 house, 3 barns; ditches filled-4.6 miles; channel reconnections-18; channel construction-5.5 miles; natural channel restoration-14 miles.

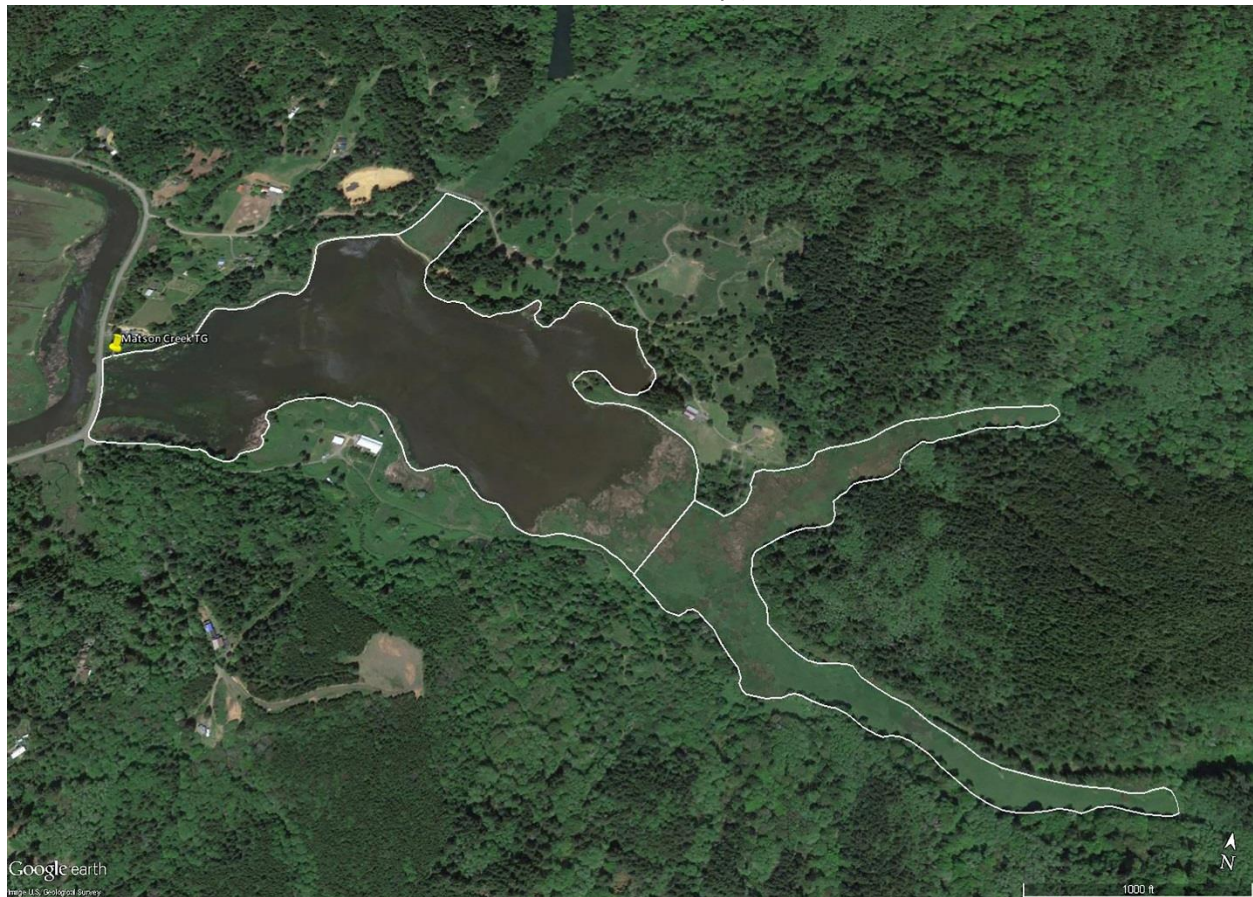
After Phase 1 restoration – tidal reconnection in lower valley (5/1/2015):

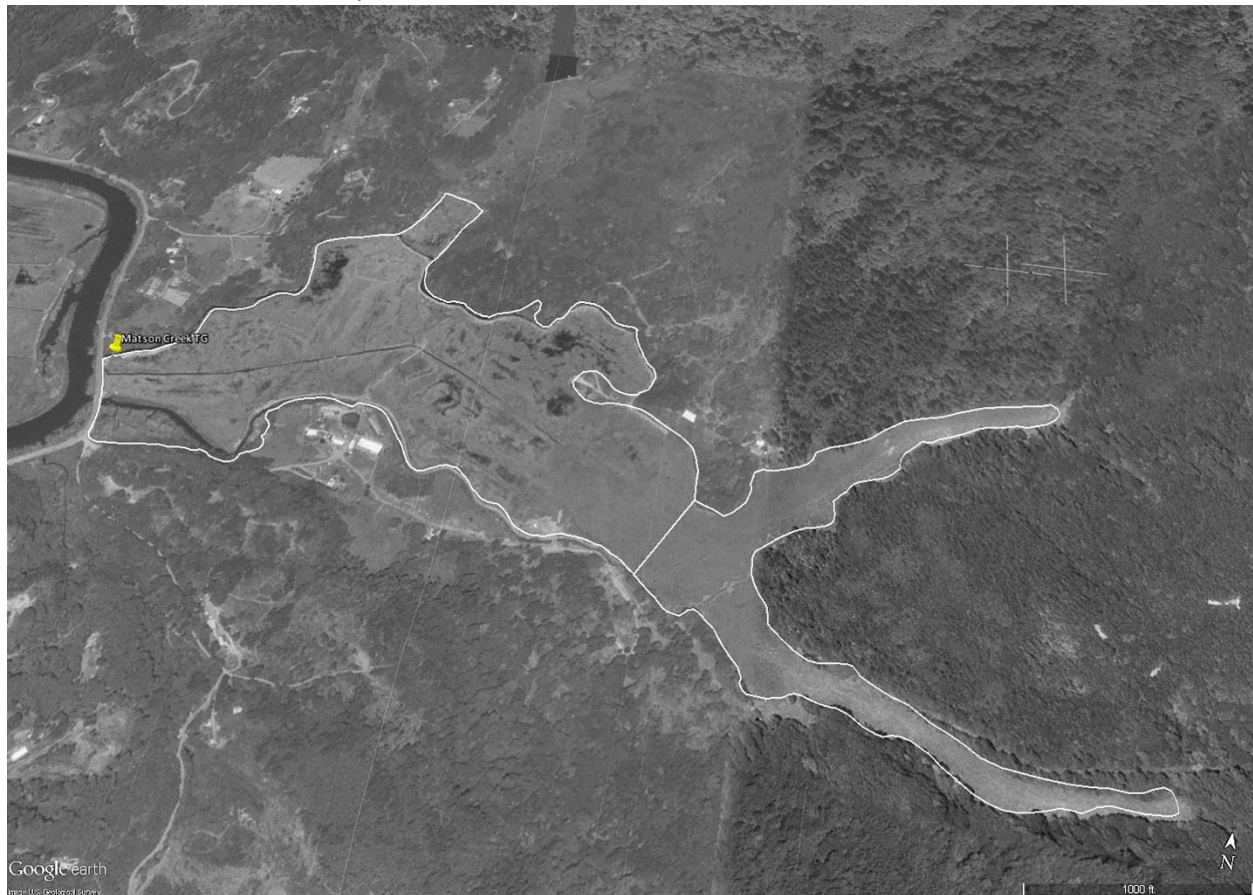
Before restoration at time of purchase (8/7/2000):

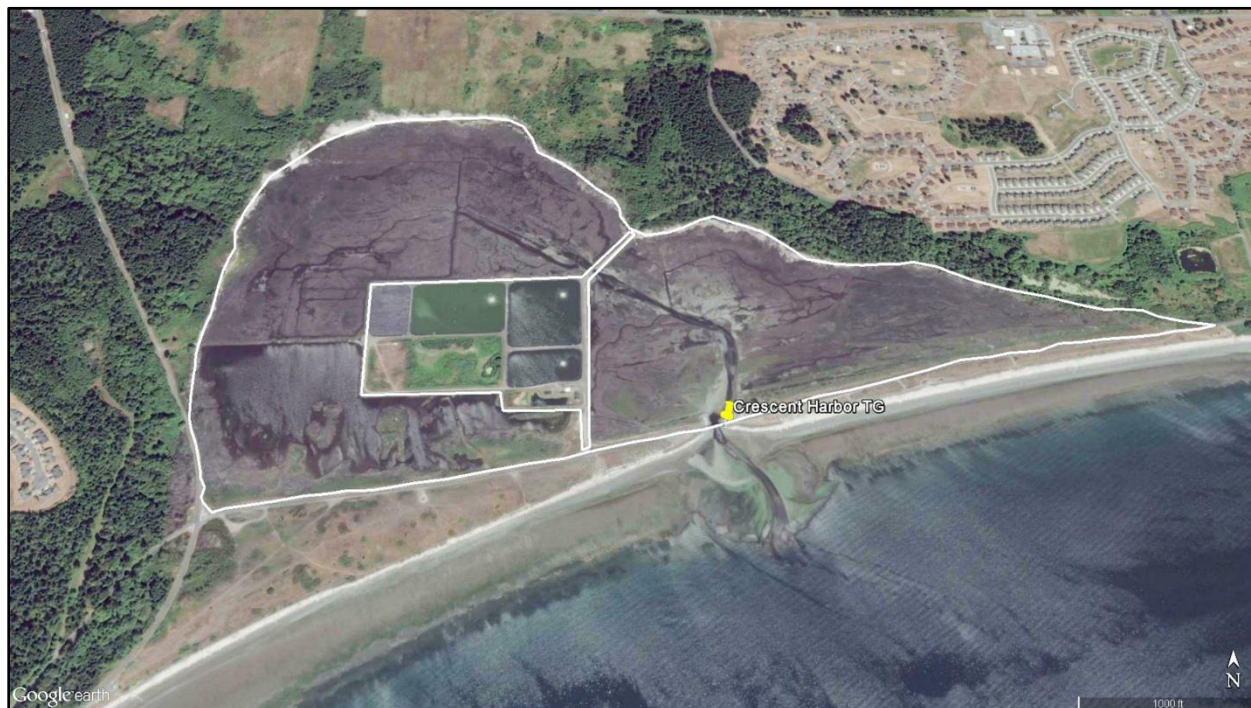
Aerial Images: Crescent Harbor after tidal reconnection (photo image 8/3/2016).

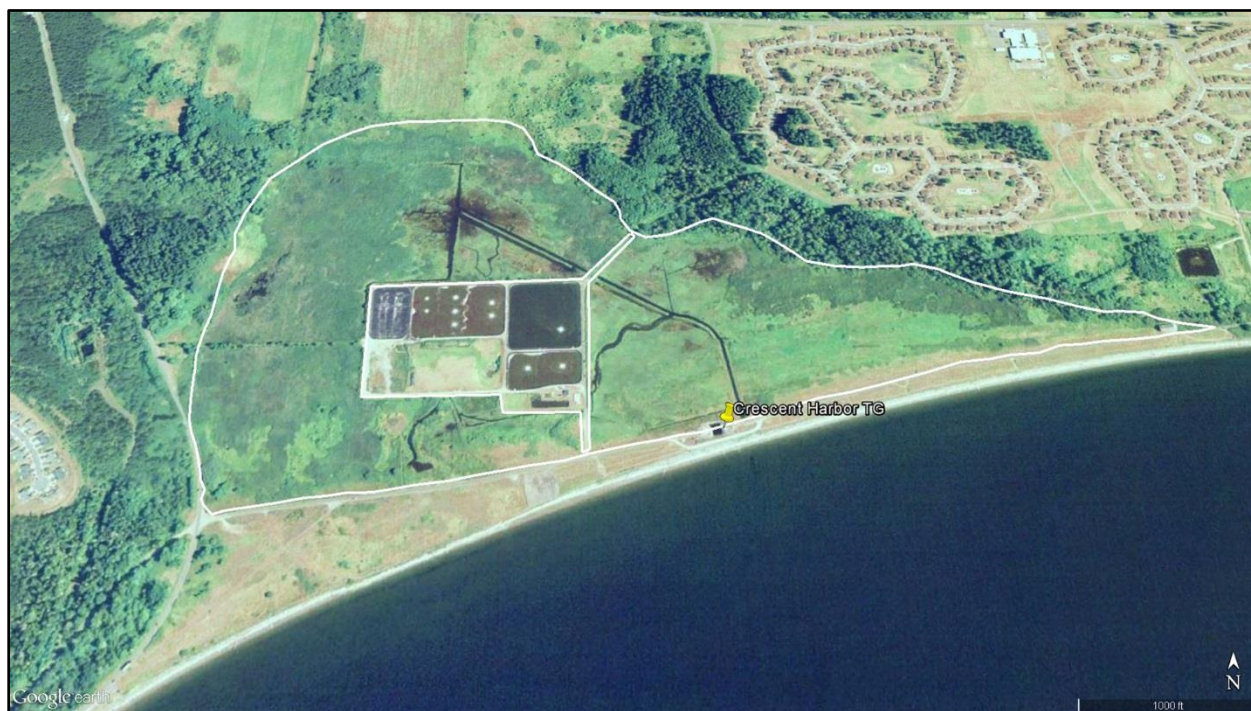
Crescent Harbor, before restoration (7/31/2005).

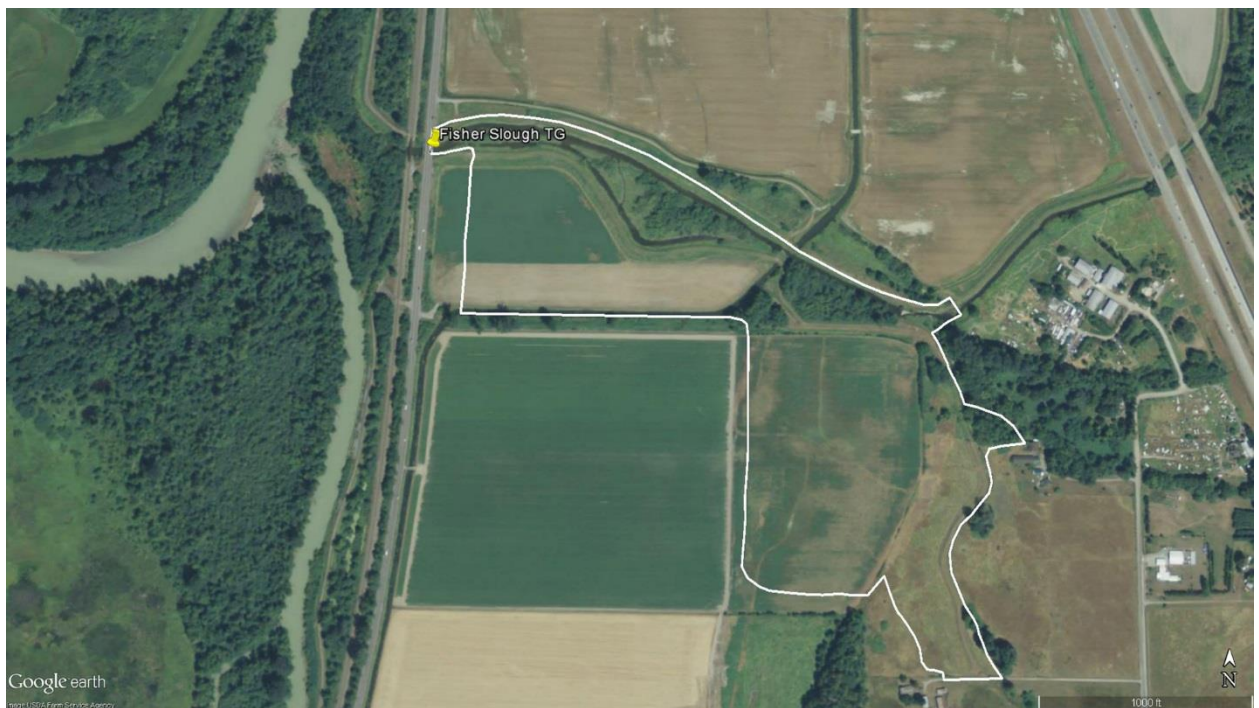
Fisher Slough, before restoration activities, (6/25/2009).

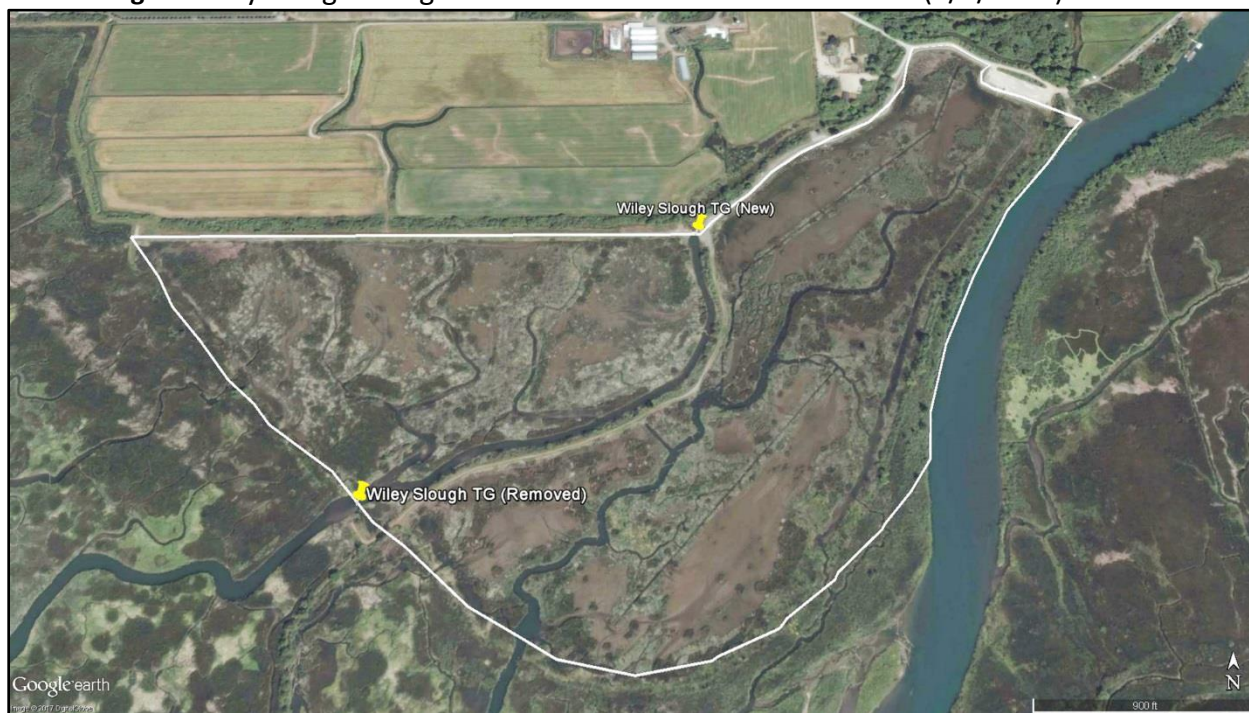
Aerial Images: Wiley Slough tide gate relocation and tidal reconnection (8/3/2016).

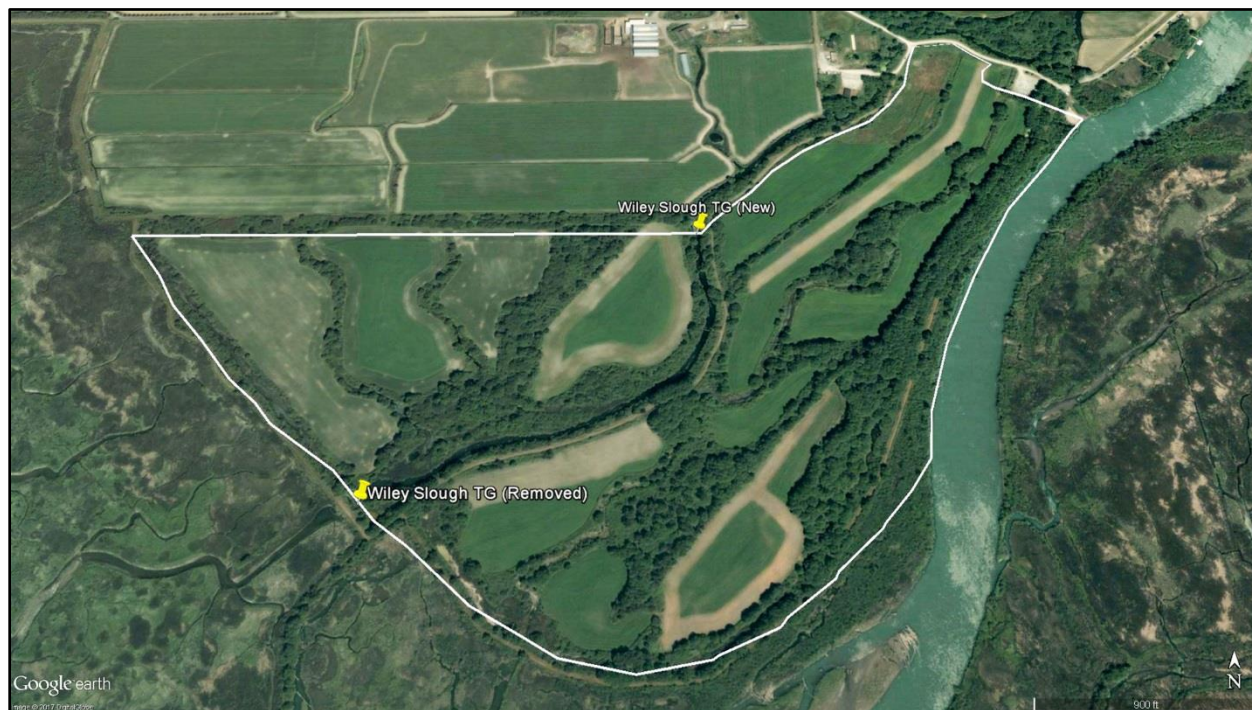
Wiley Slough, before restoration activities (7/9/2009).

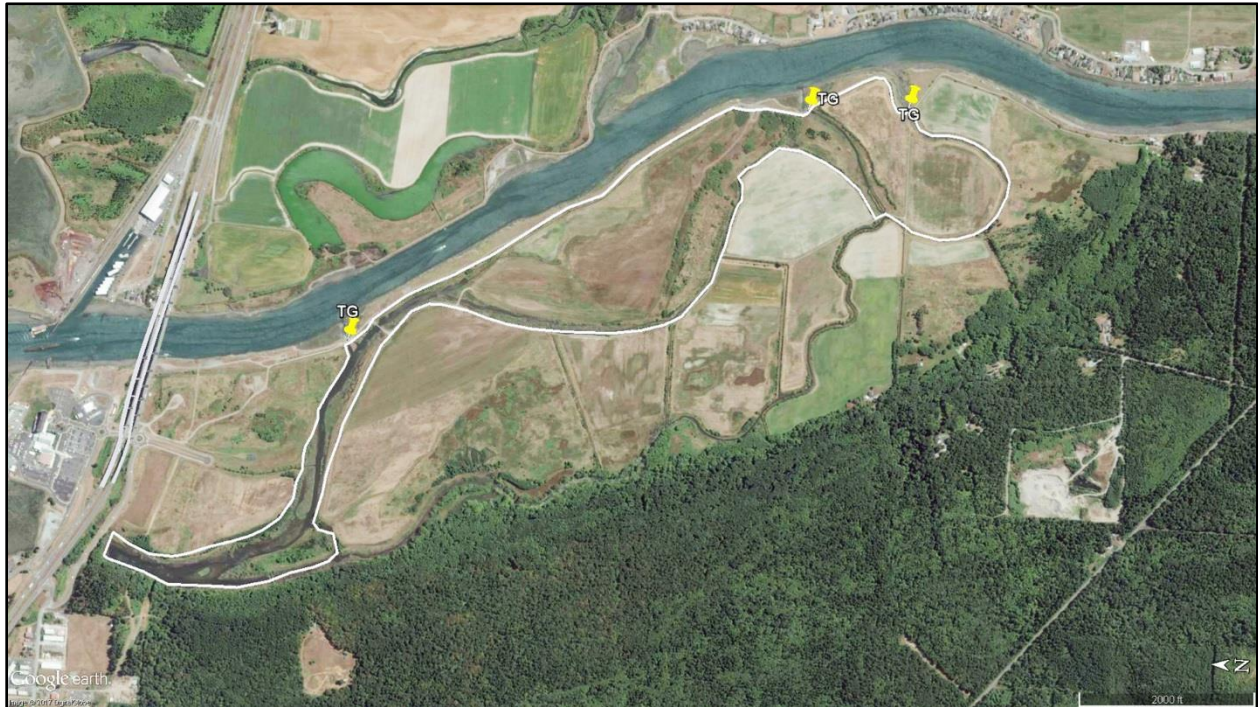
Aerial Images Smokehouse Floodplain reconnection and Fornsby Creek tide gate replacements (8/3/2016). Note image is oriented with North on the left.

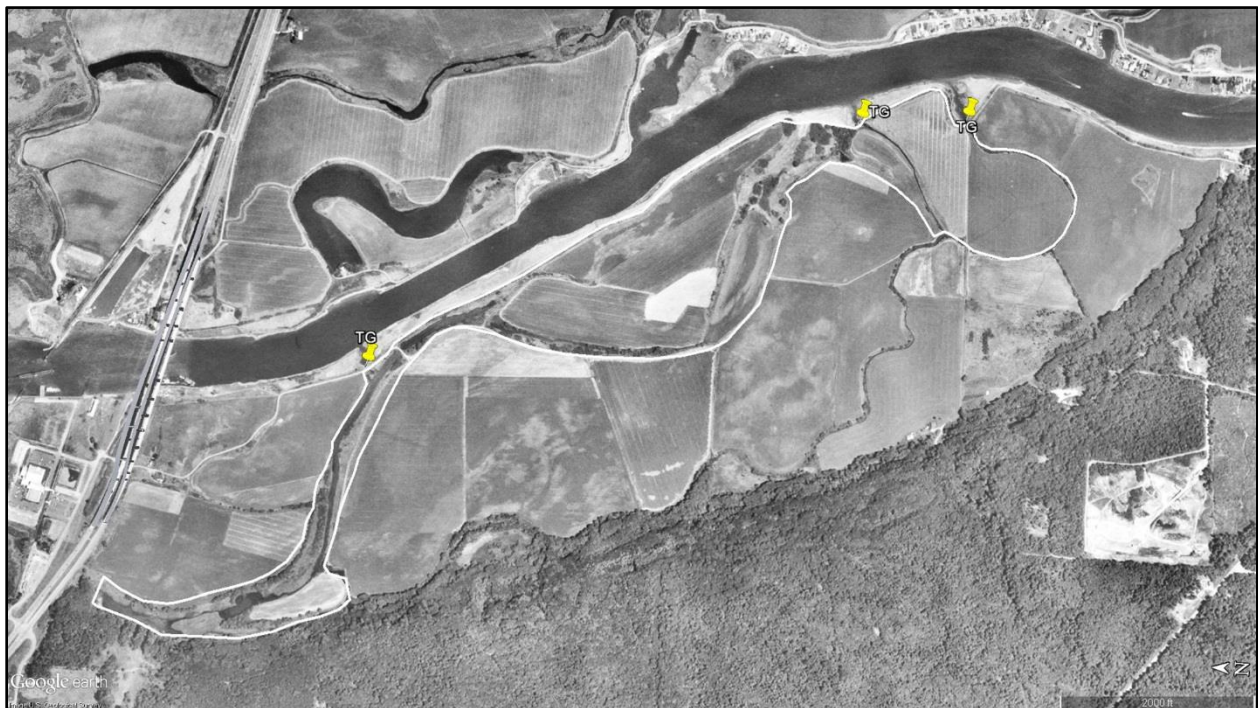
Figure _. Smokehouse Floodplain reconnection before restoration activities (7/31/2005).

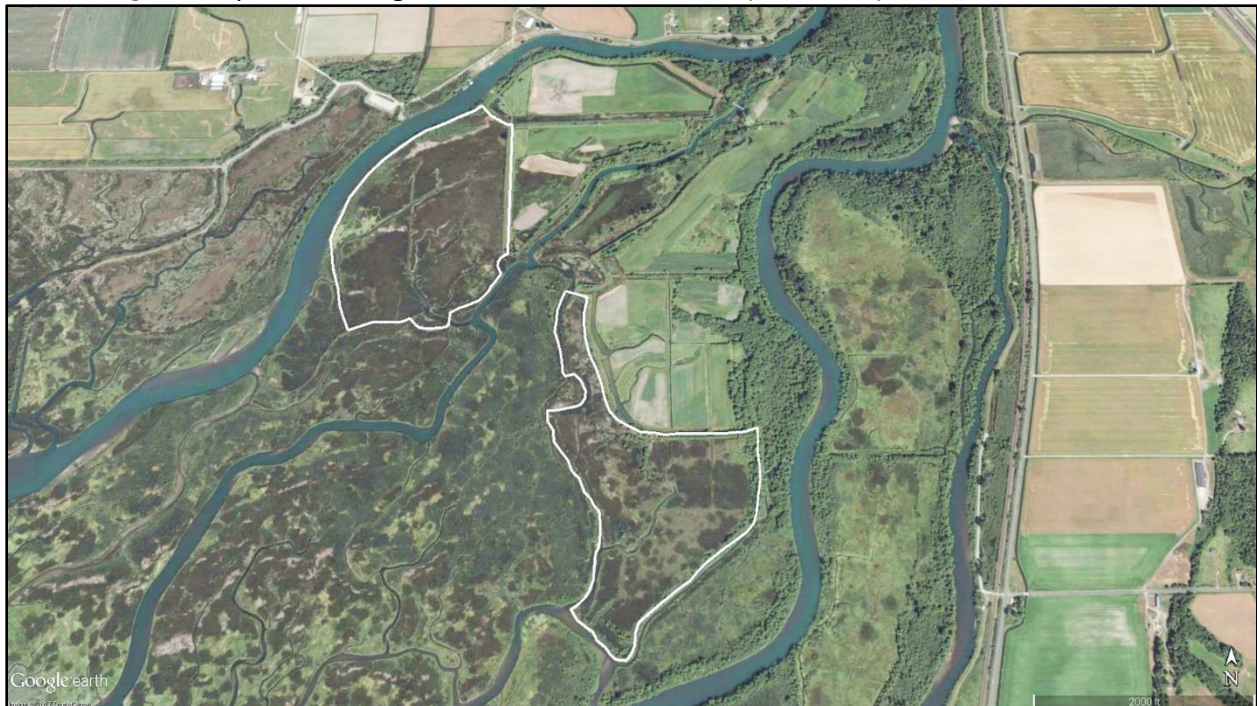
Aerial Images: Deepwater Slough after tidal reconnection (8/3/2016).

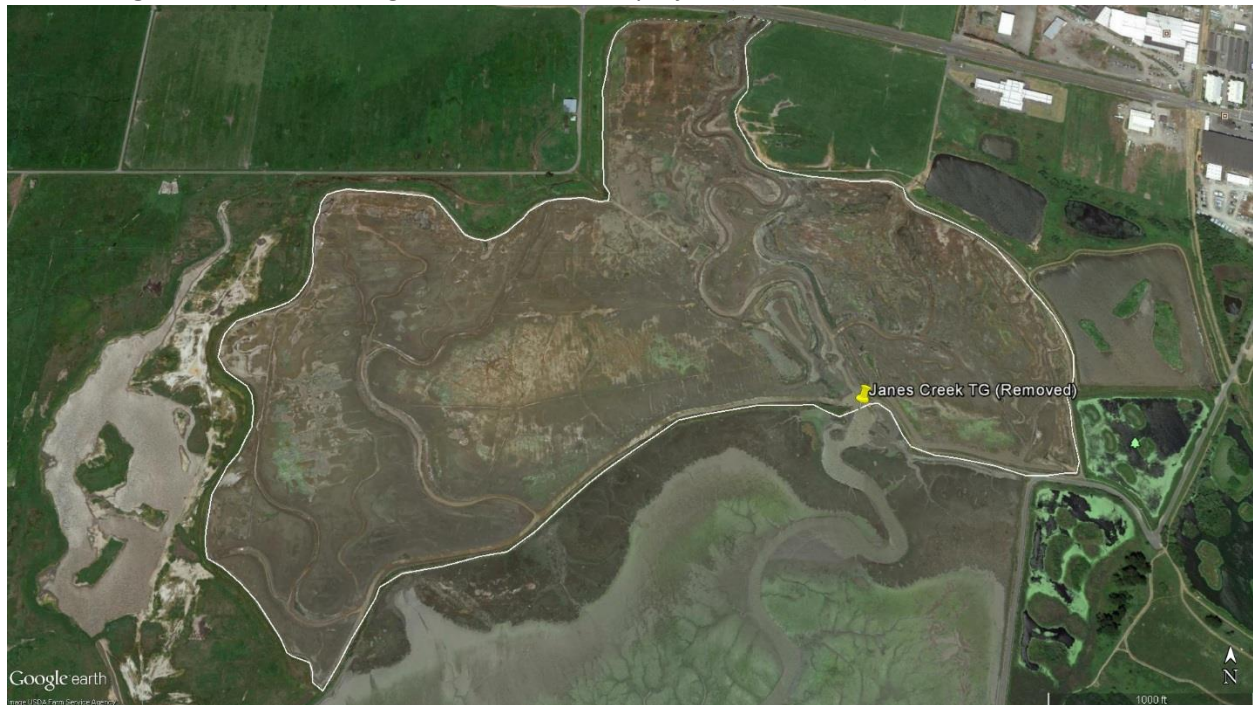
Aerial Images: Janes Creek tide gate removal – after project (5/26/2016)

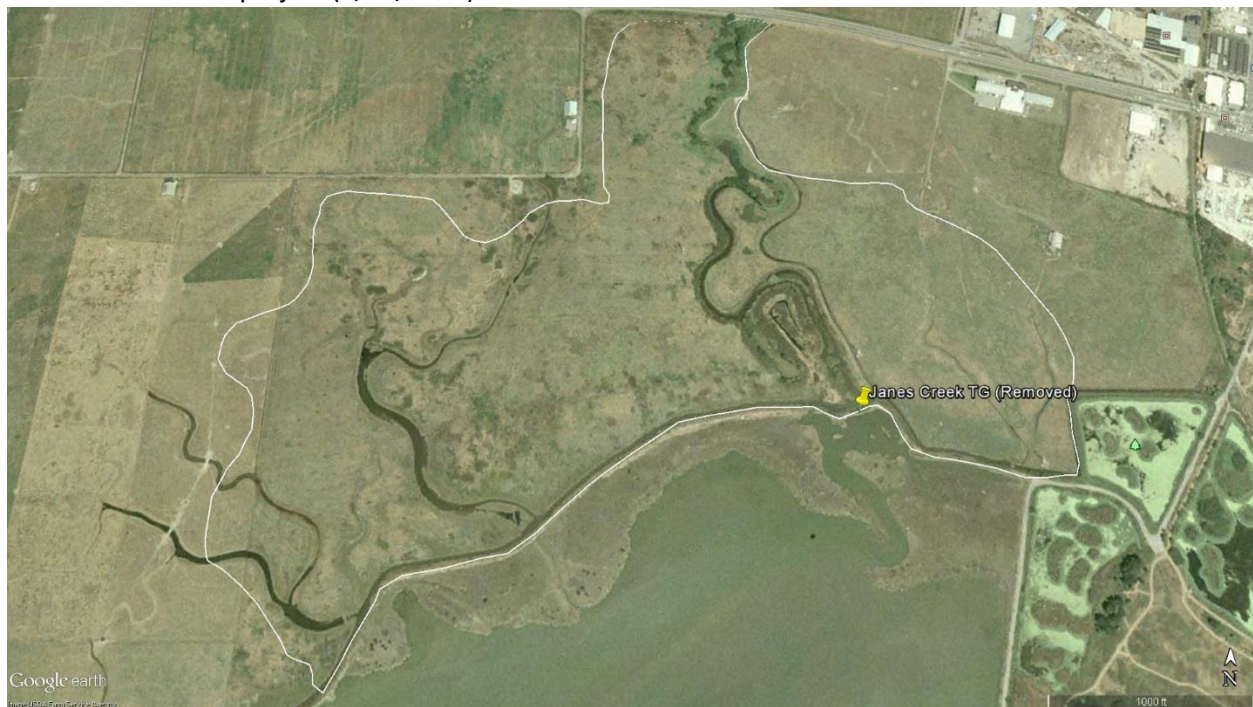
Janes Creek before project (6/30/2004):

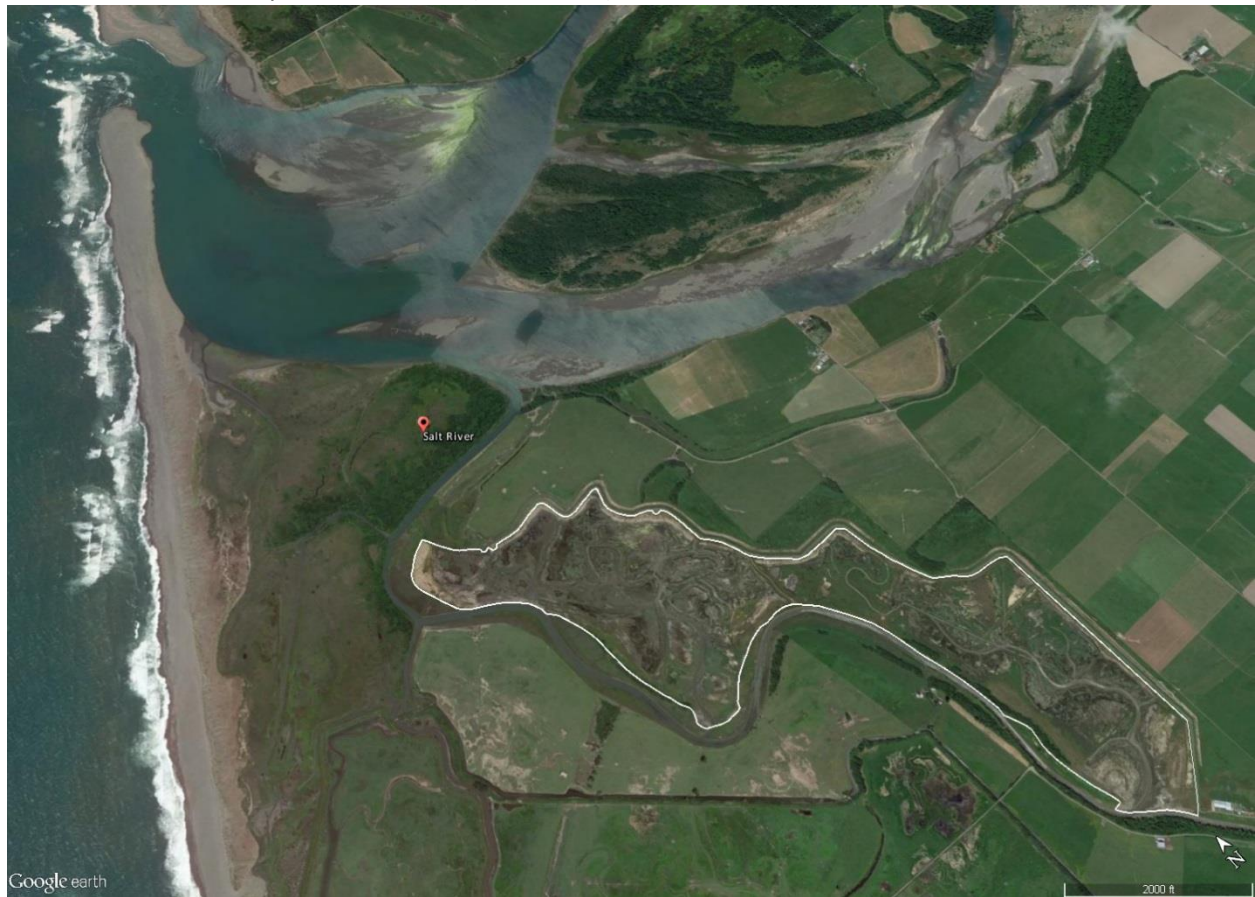
Salt River – Lower Eel post-restoration (5/26/2016):

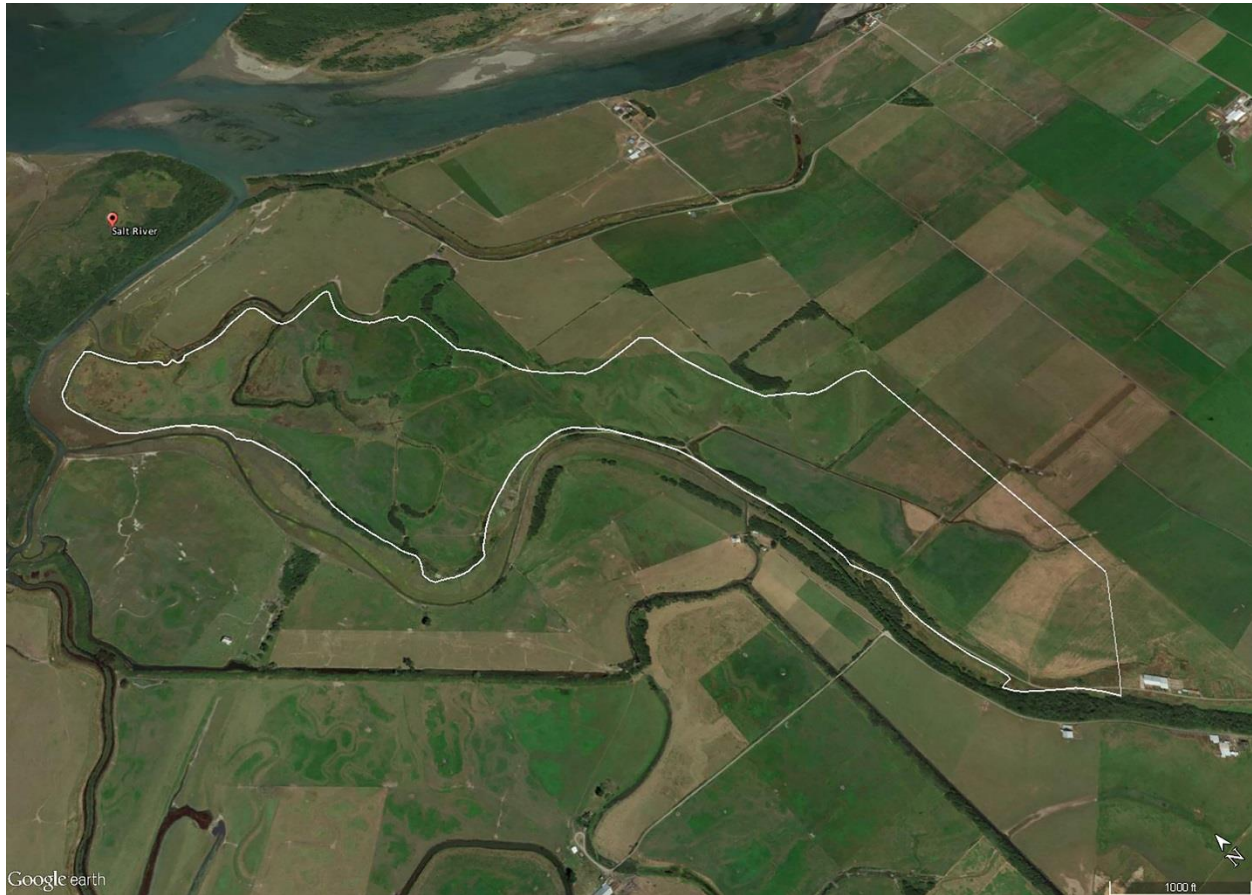
Salt River – Lower Eel pre-restoration (8/23/2012):
